Manhole Inspection Summary

Manhole # S65Q__004MH

Insp Date: **4/23/08 11:00 AM**

Location Address: **1420 Bonsal St.**

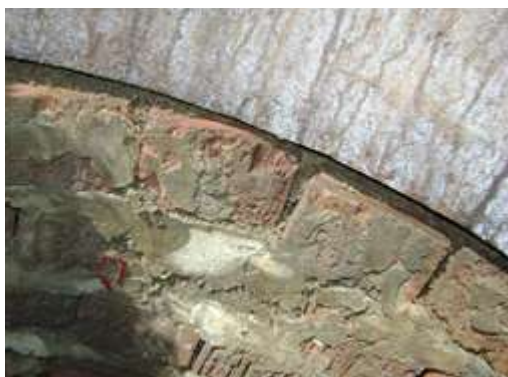
Defect 4

Infiltration

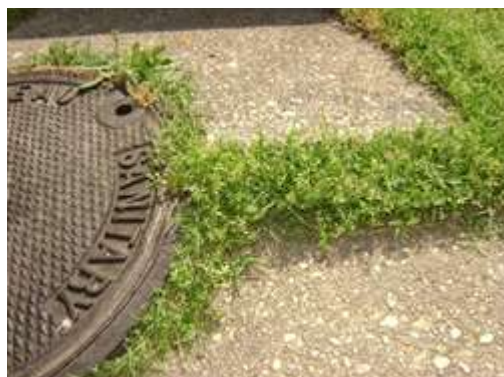
Defect 1

Broken Concrete

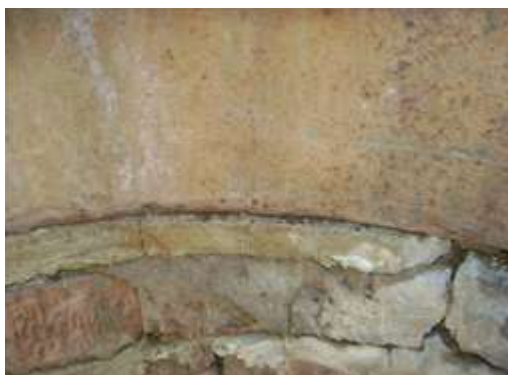
Defect 3

Condition: ☐ Sound ☐ Cracked ☐ Root Intrusion ☒ **Loose Brick** ☒ **Deteriorated**

Loose Bricks

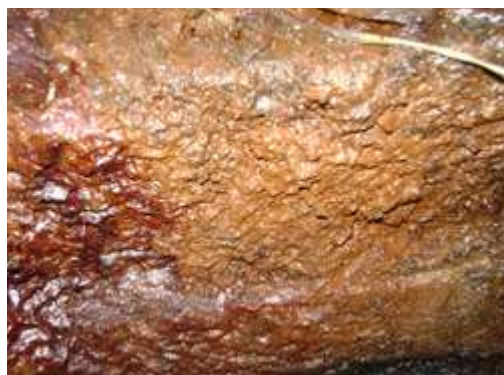
Defect 6

Condition: ☐ Sound ☐ Cracked ☐ Root Intrusion ☒ **Deteriorated** ☐ Leaks ☒ **Debris**

Buildup on bench

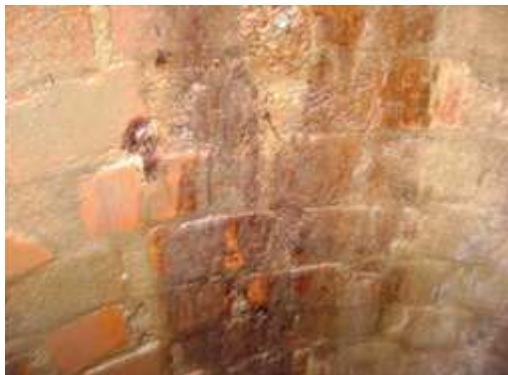
Defect 5

Infiltration

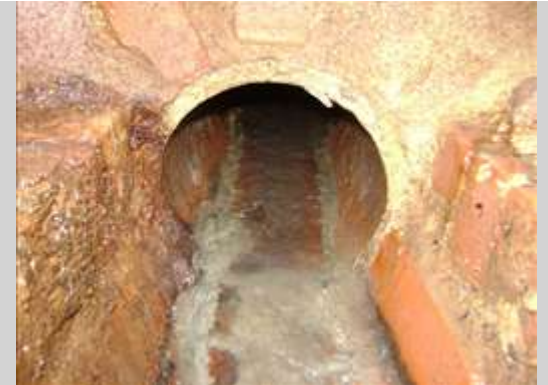
12 O'Clock Outflow

8 in. Circular Gravity Sewer
Pipe Out @ 12 O'Clock

Pipe Height: **8.4** (in.) Rod and Bar (Angled)
Pipe Material: **Clay** ☐ Pipe Lined
Invert Depth: **11.58** (ft.) Flow Characteristics: **Slow**
Deposits: ☒ None ☐ Mud ☐ Sludge ☐ Debris ☐ Grease
Silt Depth: (in.) Deposits Extent:
Infiltration: **None** Pipe Seal Cond: **Sound**

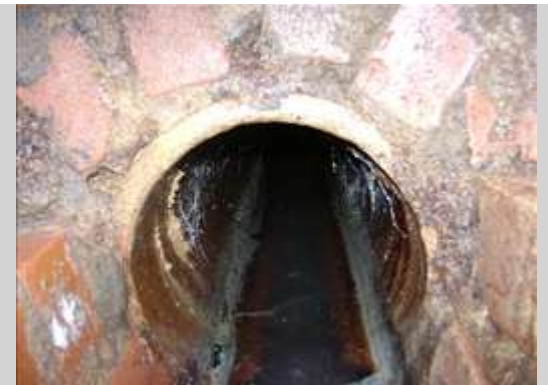
6 O'Clock Inflow

8 in. Circular Gravity Sewer
Pipe In @ 6 O'Clock

Pipe Height: **8.4** (in.) Rod and Bar (Angled)
Pipe Material: **Clay** ☐ Pipe Lined
Invert Depth: **11.25** (ft.) Flow Characteristics: **Slow**
Deposits: ☒ None ☐ Mud ☐ Sludge ☐ Debris ☐ Grease
Silt Depth: (in.) Deposits Extent:
Infiltration: **None** Pipe Seal Cond: **Sound**
